United States Department of State
and the Broadcasting Board of Governors
Office of Inspector General

Report of Inspection

The International Broadcasting Bureau's Greenville, North Carolina, Transmitting Station

Report Number ISP-IB-05-69, August 2005

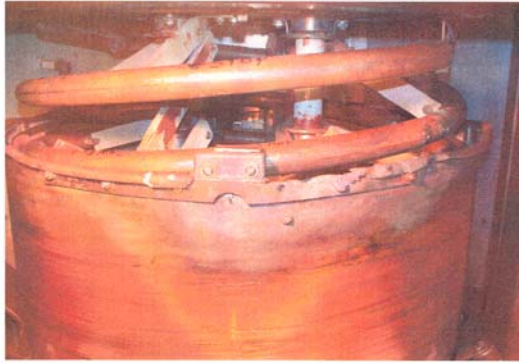
Sites A and B are both faced with preventive and scheduled maintenance challenges; however, site A has suffered much more wear and tear. Although site A is of about the same age and design as site B, the transmitters and other equipment at site A are in much worse shape. A senior radio technician said preventive maintenance was difficult to keep up with, in part because of the lack of manpower and because of poor relations between employees and between employees and managers. Management confirmed that preventive and scheduled maintenance is hampered by an April 29, 2002, memo from former station management rescinding the Greenville Transmitter Plant's standing operating procedures and "directed the acting transmitter plant supervisor not to continue to issue policy or instructions in this form²." As noted, management had decided that standing operating procedures were not an appropriate way to instruct shift supervisors.

Figure 4: Worn and patched shorting drum (inside of transmitter) at site A.

Recommendation 3: The International Broadcasting Bureau should work with the Greenville Transmitting Station to reestablish a mandatory preventive maintenance program and provide the resources to implement the program. (Action: IBB)
